**MUNICIPAL SEPARATE STORM
SEWER SYSTEM (MS4)
COMPLIANCE AUDIT**

**STATE OF CALIFORNIA,
DEPARTMENT OF TRANSPORTATION**

**REPORT DATE:
February 26, 2010**

**EVALUATION CONDUCTED:
October 5–7, 13–14, and 21–22, 2009**

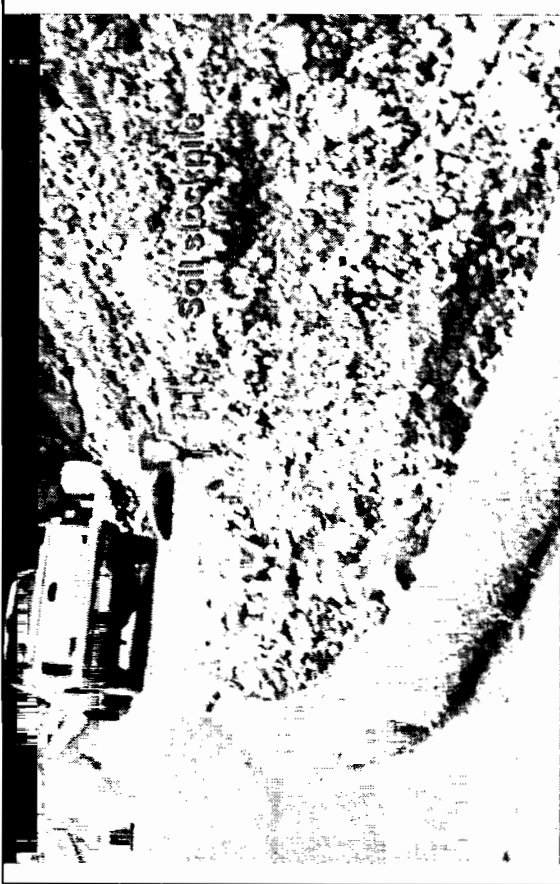
In addition, straw wattle BMPs used for stockpile management were improperly installed on impervious surfaces at the facility, and therefore were not properly entrenched in the ground to retain the stockpiled materials (see Photographs 13 and 14). As a result, there was a potential for the discharge of sediment to the roadway and off-site to the west. The Resident Engineer explained that the SWPPP had been amended to include the use of straw wattle BMPs on impervious surfaces; however, this was not confirmed by the EPA Audit Team.

<p>Photograph 13— Straw wattle not staked or entrenched into ground. Inappropriate application of wattles on impervious surface.</p>	<p>Photograph 14— Another example of straw wattle not staked or entrenched into ground. Inappropriate application of wattles on impervious surface.</p>

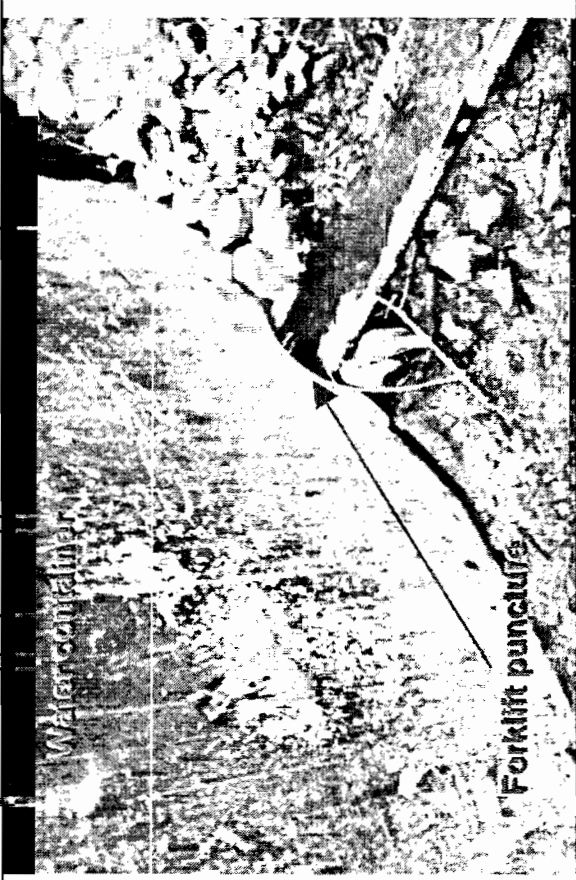
The EPA Audit Team observed that a water storage tank (approximately 1,000-gallon capacity) located up-gradient had been punctured by a forklift and was leaking (see Photographs 15 and 16). Water was observed slowly flowing underneath the straw wattle BMPs that been placed on the impervious roadway surface adjacent to K-rail barriers near the southern end of the construction project (see Photograph 17). The straw wattle BMPs had been installed prior to the puncture incident. Water had flowed underneath the straw wattles and jersey barriers and was observed on the adjacent roadway (see Photograph 18).

<p>Photograph 15— View of forklift that had punctured the water container</p>	<p>Photograph 16— Close-up view of puncture in water container</p>

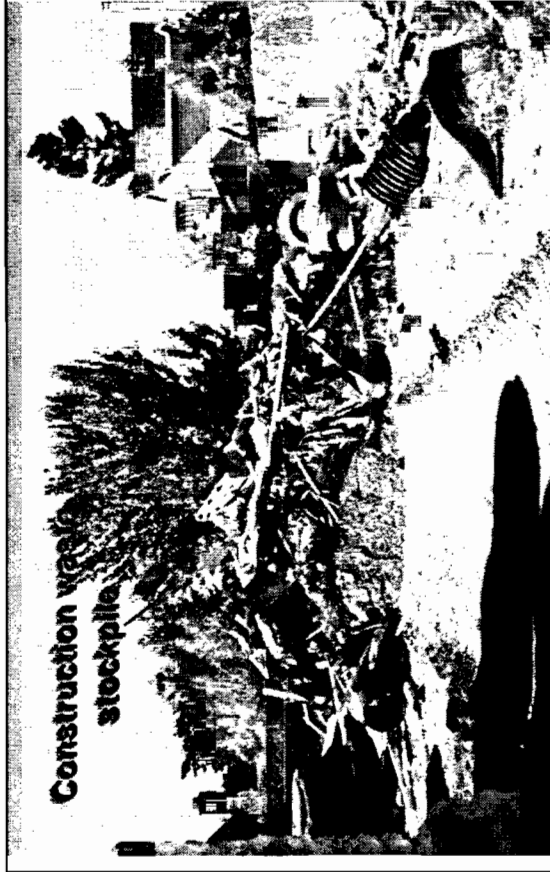
Photograph 5—Uncovered and uncontained construction waste

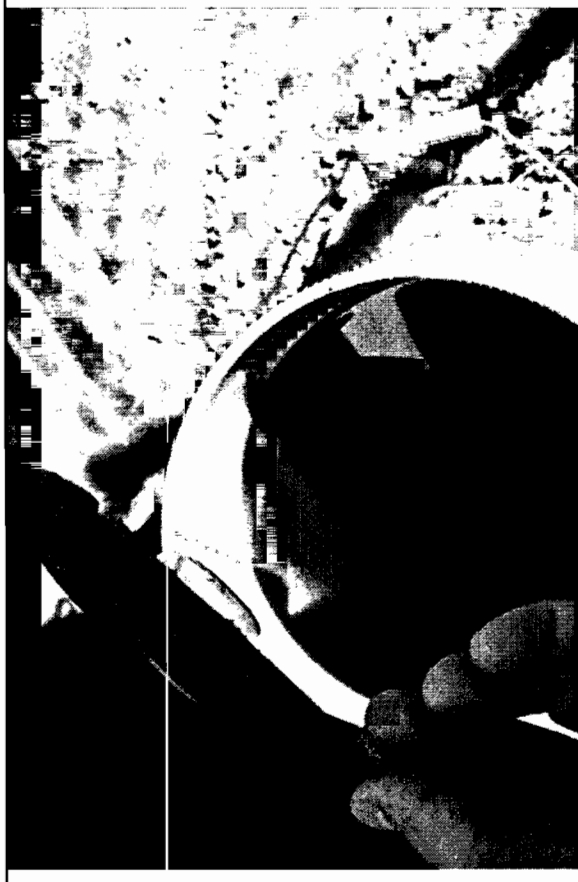
Photograph 8 – Petroleum product without secondary containment

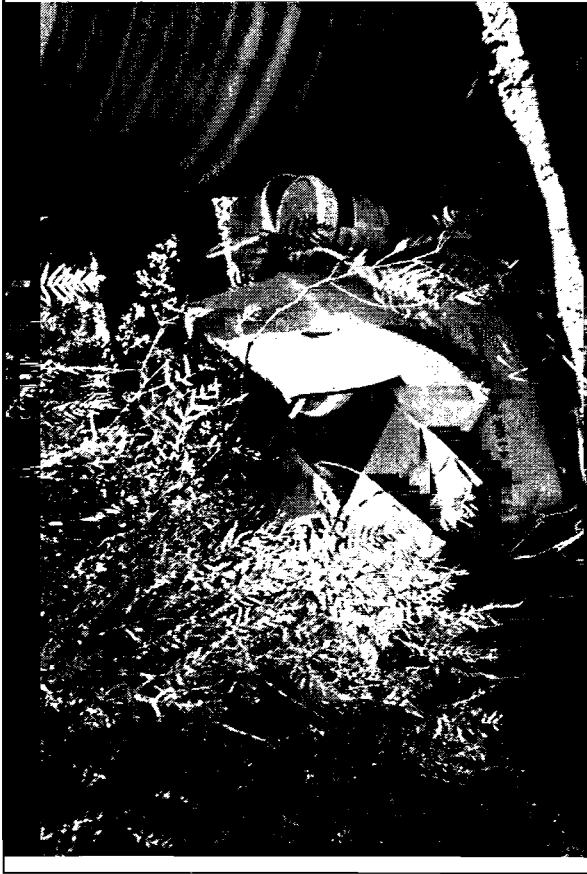
Photograph 9— Pipe joint lubricant

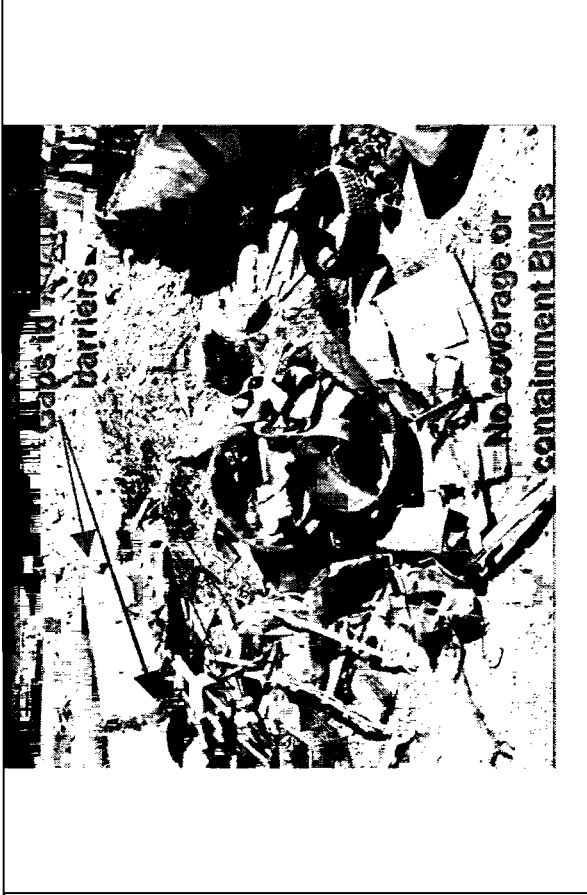
Photograph 10 – Sweeper and roadway waste stockpile

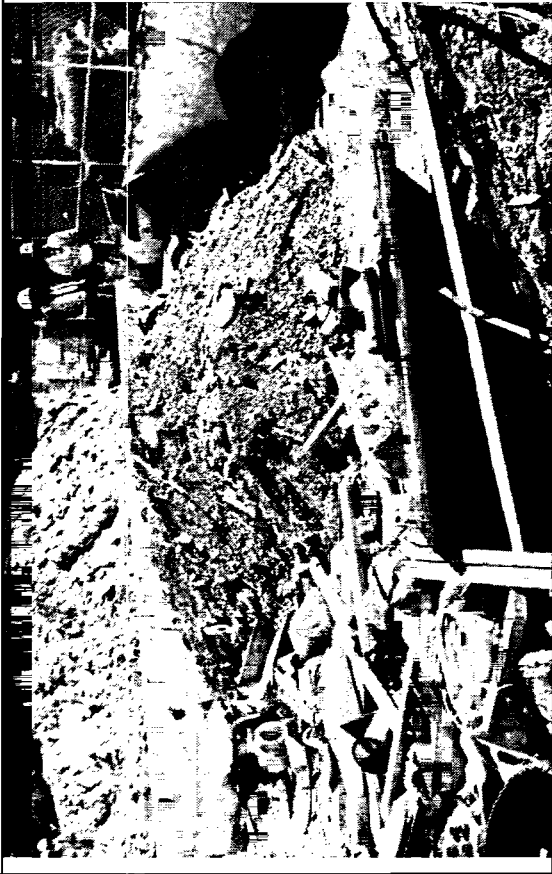
Photograph 11— Close-up view of sweeper and roadway waste stockpile

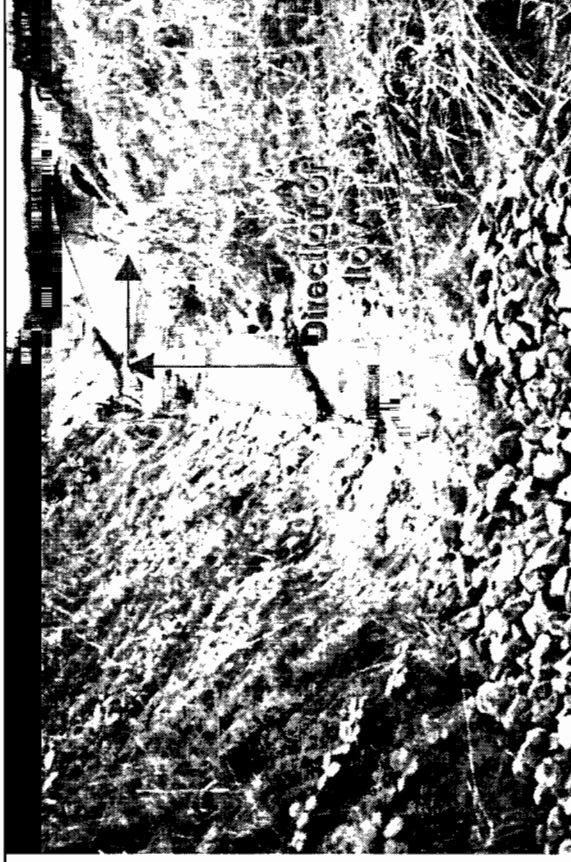
Photograph 2 – Closer view of disturbed drainage ditch and culvert inlet

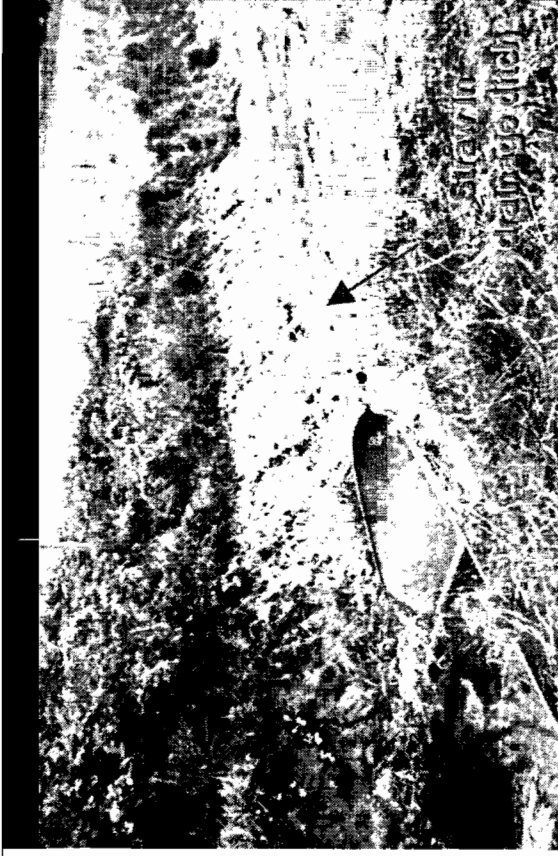
Photograph 5— View of drainage ditch south of the culvert inlet

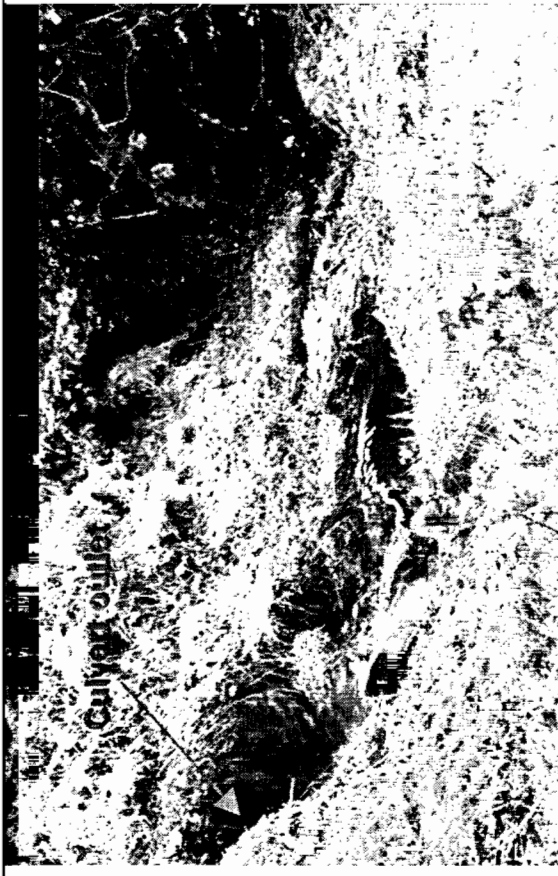
Photograph 6 – West side of culvert outlet (Note: Straw around and within drainage channel)

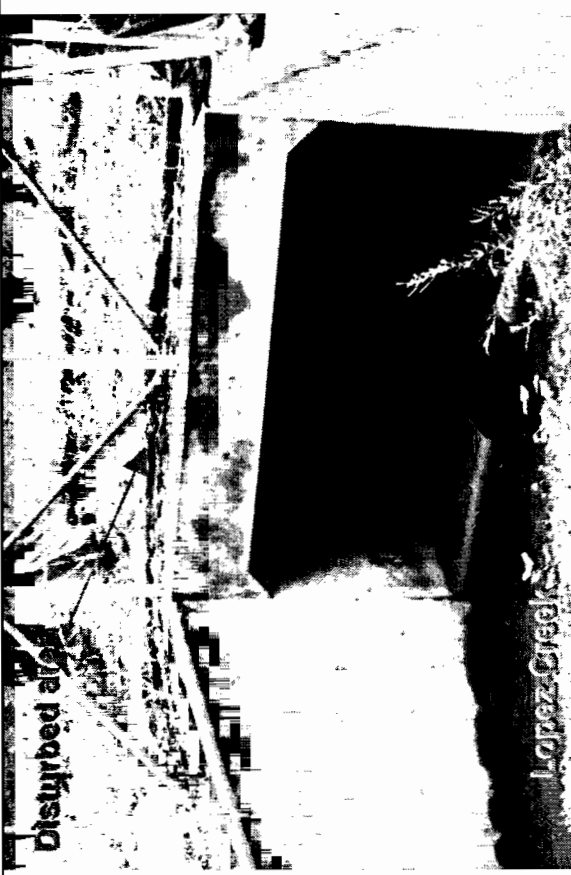
Photograph 10— Culvert crossing of Lopez Creek

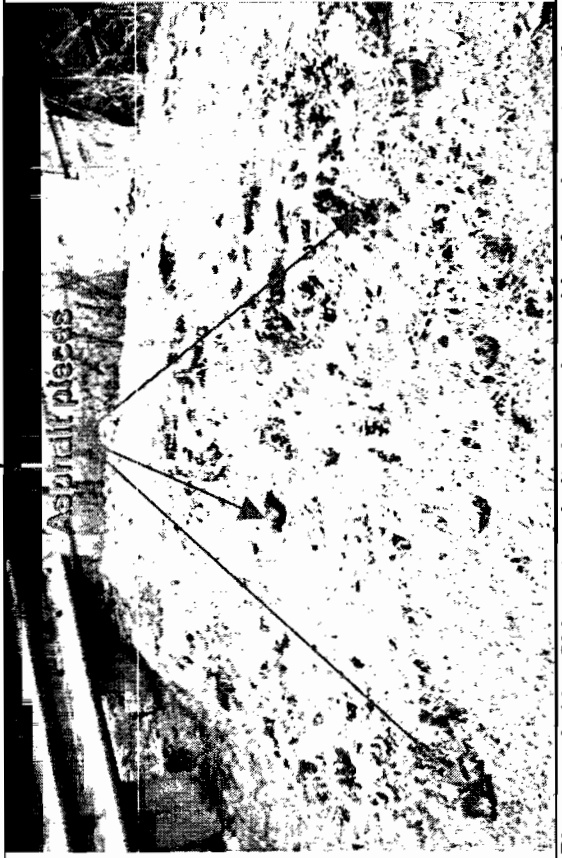
Photograph 11— Sidecast asphalt pieces along side of roadway at northern end of construction project

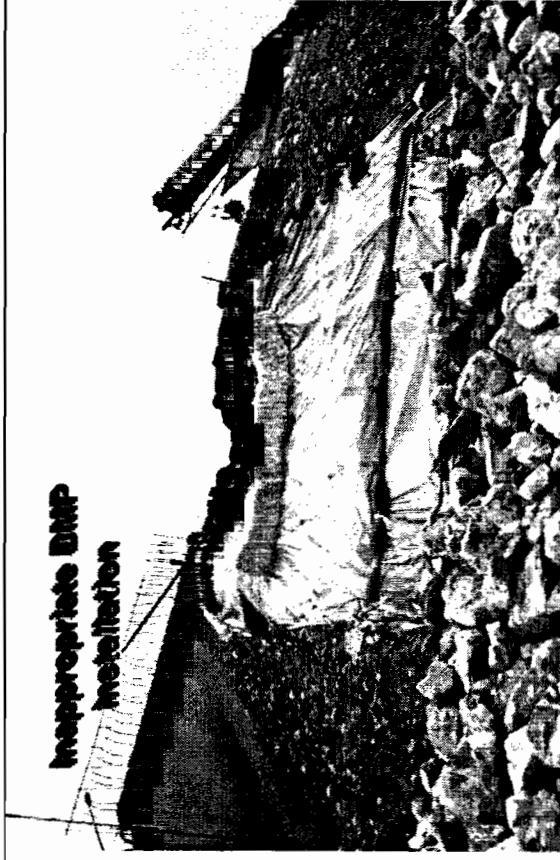
Provision H.1.b of the Permit requires Caltrans to implement a program to control all construction in the rights-of way and states that “program must include requirements of structural and nonstructural BMPs.” Appendix D of the SWMP contains the “Statewide Storm Water Quality Practice Guidelines” which provide a description of each approved BMP for statewide application. Adequate BMPs were not implemented for the disturbed areas associated with the replacement construction of the Sacramento River Bridge (a four span concrete box girder bridge replacement). Specifically, portions of the disturbed slope area along the southeastern side of the bridge had been temporarily stabilized and the hay bale flow dissipation BMPs had been improperly installed on an impervious surface (see Photograph 1).

Photograph 1 – View of disturbed slope at Sacramento River Bridge

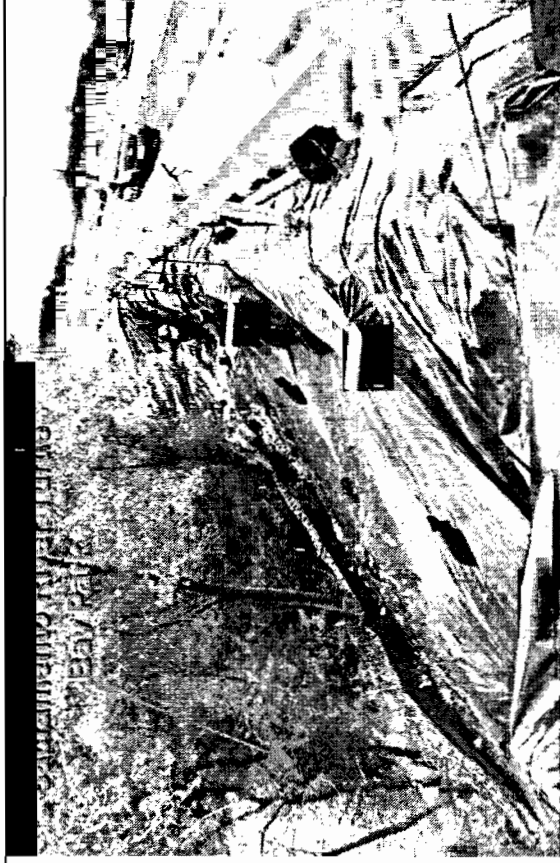
In an area along the northern portion of Interstate 5 and east of the Auditorium Drive Bridge, a perimeter control silt fence located at the toe of the slope had failed (see Photographs 2 and 3). As a result, there was potential for the discharge of sediment offsite into the Sacramento River Turtle Bay Park (see Photograph 3).

Photograph 2 – View of temporary plastic slope stabilization along the north side of I-5, at the terminus of the bike path

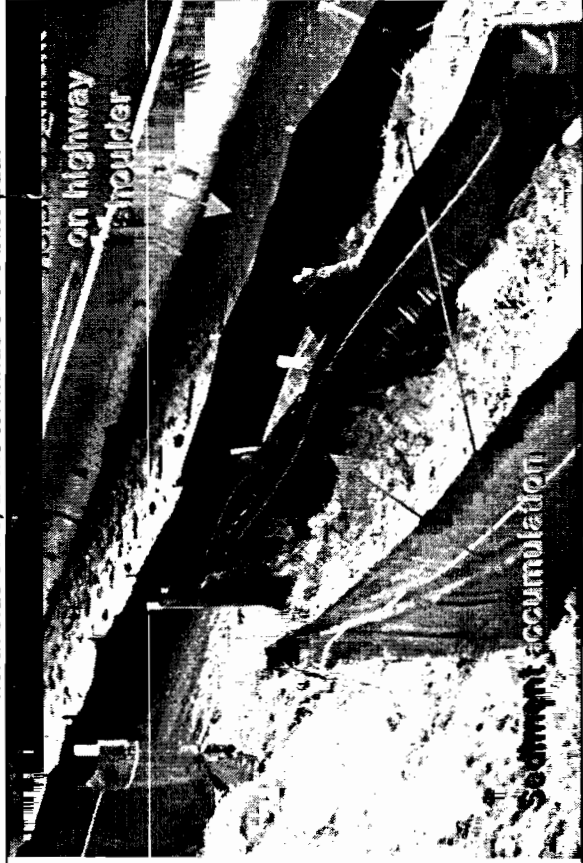
Adequate BMPs were not implemented for disturbed areas associated with the disturbed slope area under the Auditorium Drive Bridge overpass replacement and construction. Specifically, silt fence BMPs had accumulated sediment to approximately half the exposed silt fence height in several areas (see Photograph 4). Although three tiers of silt fence had been installed for BMP redundancy, the tiers were in need of maintenance (see Photograph 4), and sediment was visible beyond the BMPs on the highway shoulder.

Photograph 4 – Silt fence on the north side of I-5, view facing south-southeast

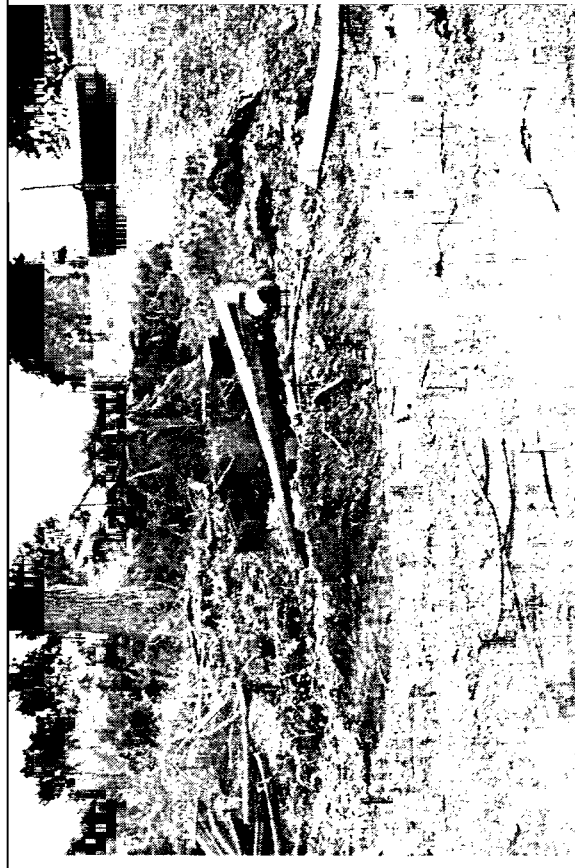
Photograph 5 – Lack of perimeter control BMPs around a construction material disposal stockpile

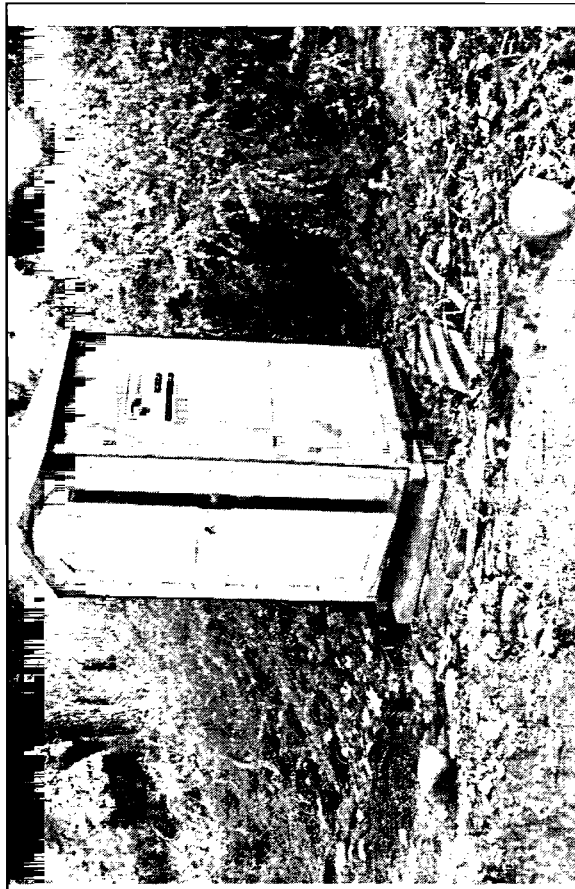
Photograph 6 – View of unsecured portable toilet

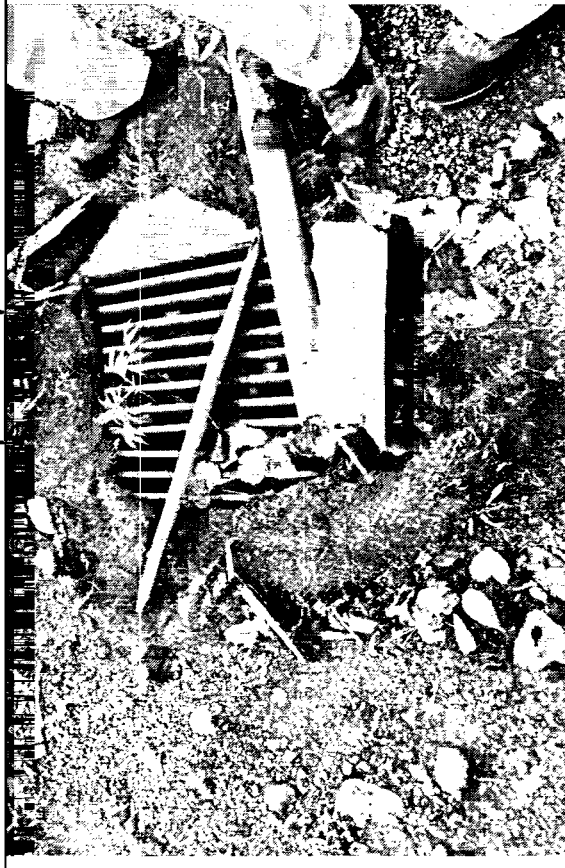
Moreover, adequate BMPs were not implemented and maintained to prevent the discharge of sediment and debris at inlets located at the staging area on the southeast corner of the Auditorium Drive Bridge and along the bike path on the north side of Interstate 5 adjacent to the Auditorium Drive Bridge main staging area. The straw wattle implemented at the drop inlet located near the Auditorium Drive Bridge was badly deteriorated and had not been properly entrenched (see Photograph 7). Although rock sacks had been installed to protect the inlet, sediment had accumulated around and in the storm drain inlet located along the bike path (see Photograph 8).

Photograph 7 – Storm drain inlet at the northwestern portion of the Auditorium Drive Bridge temporary staging area

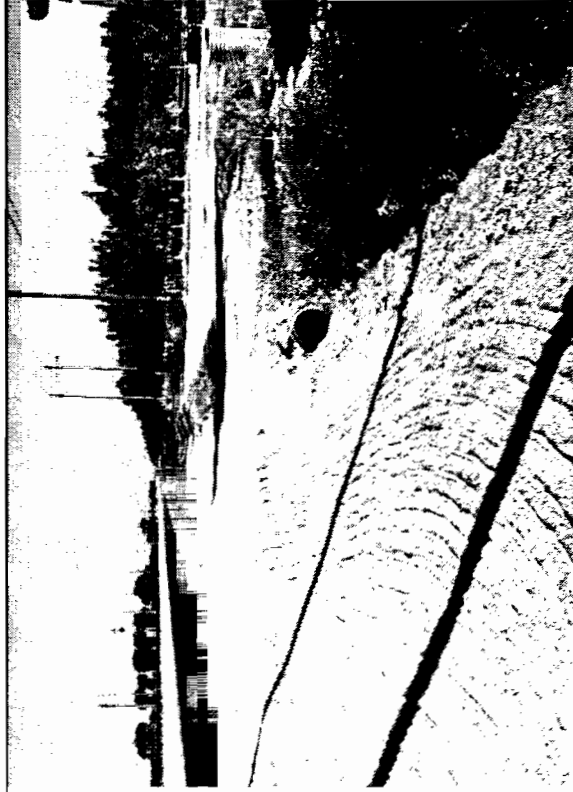
Photograph 1 – Drainage swale adjacent to roadway without adequate BMPs implemented (Drill seeding only)

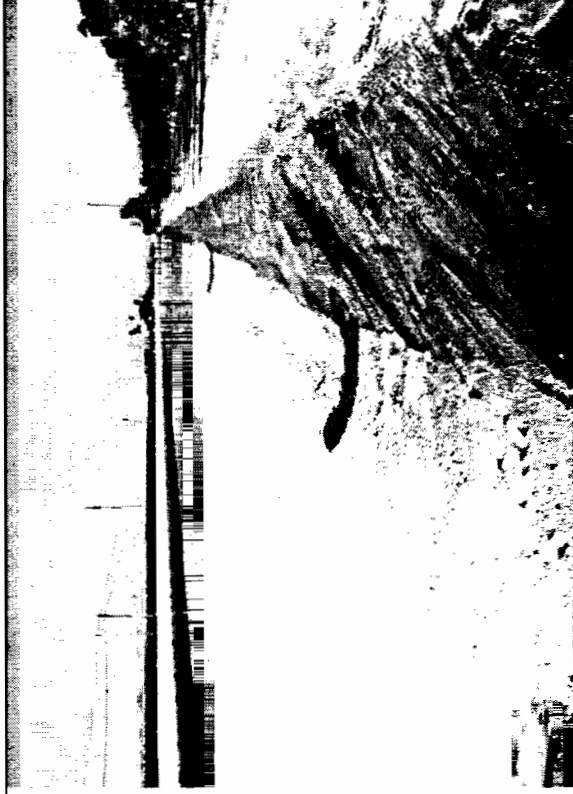
Photograph 2 – Unstabilized drainage swale and slope adjacent to roadway

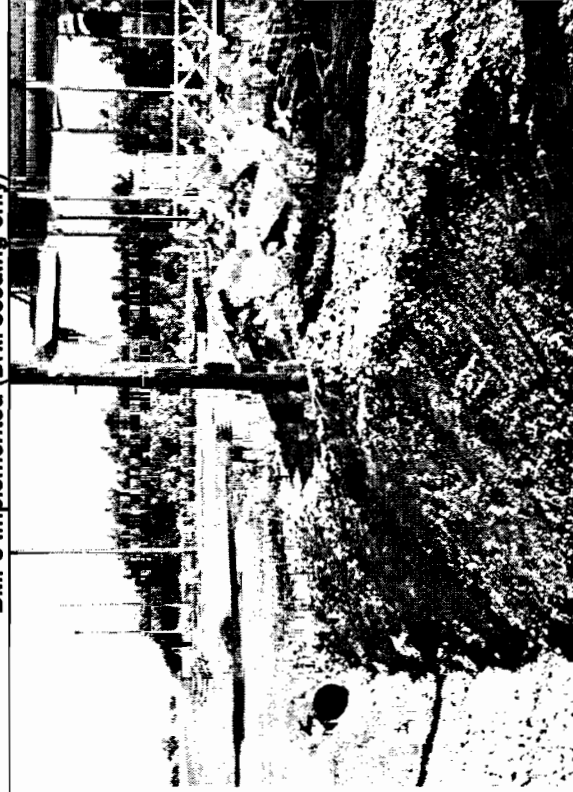
Photograph 3 – Uncontained concrete waste adjacent to roadway drainage swale

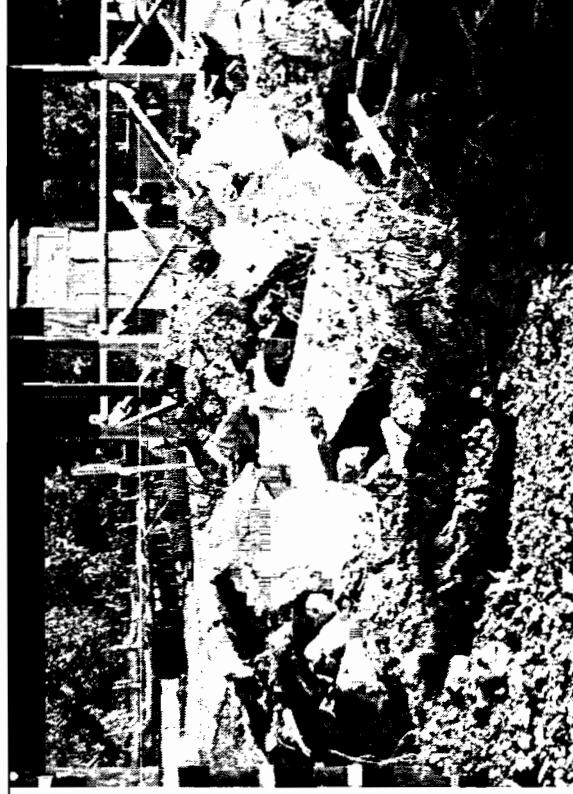
Photograph 4 – Close-up of Photograph 3 and concrete waste

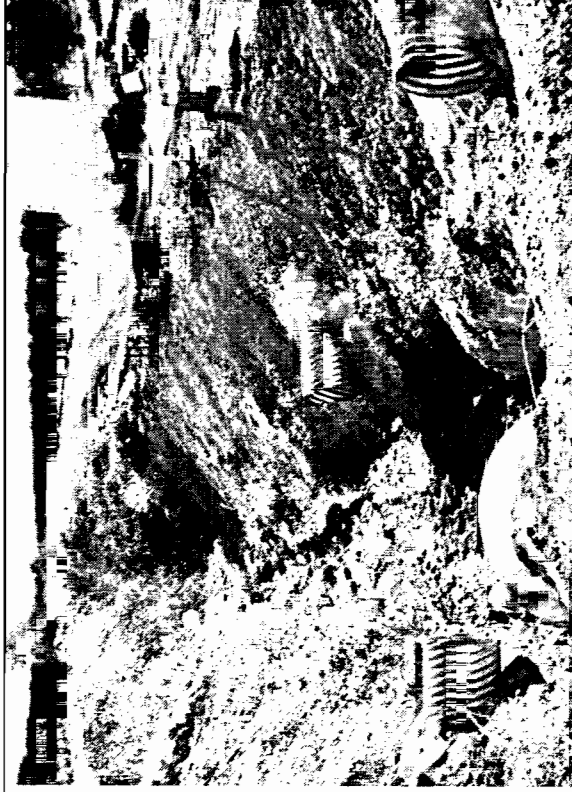
Photograph 5 – View looking upgradient on irrigation channel located adjacent to project. Note unstabilized slopes adj. to irrigation channel.

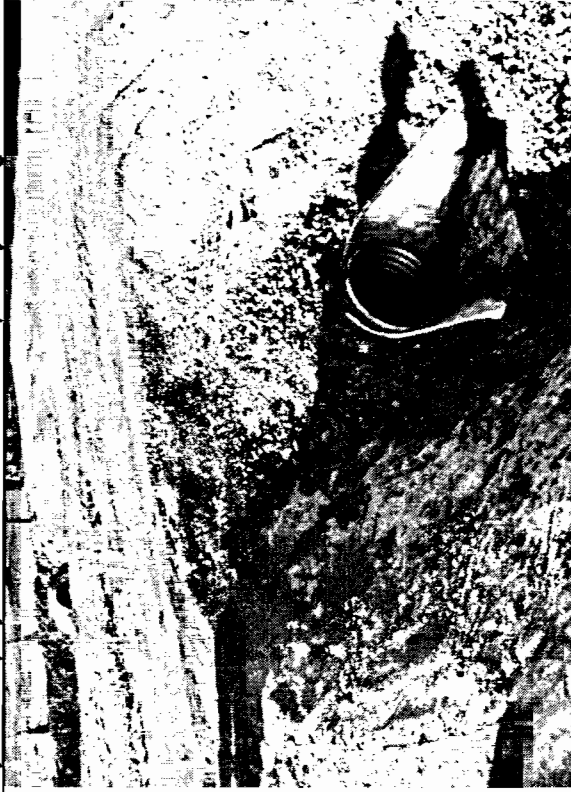
Photograph 7 – Culvert pipe inlet with no BMPs implemented – drains to irrigation ditch.

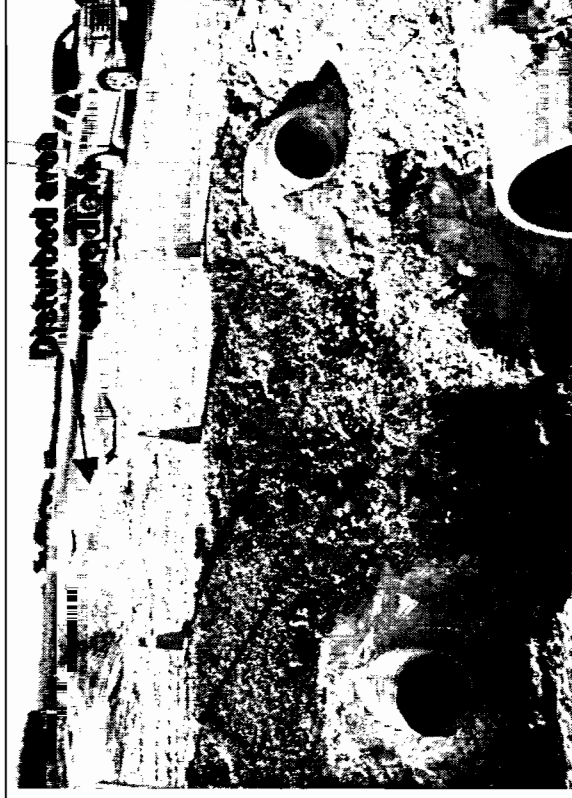
Photograph 6 – Culvert outlet pipes and disturbed embankment slope in irrigation ditch

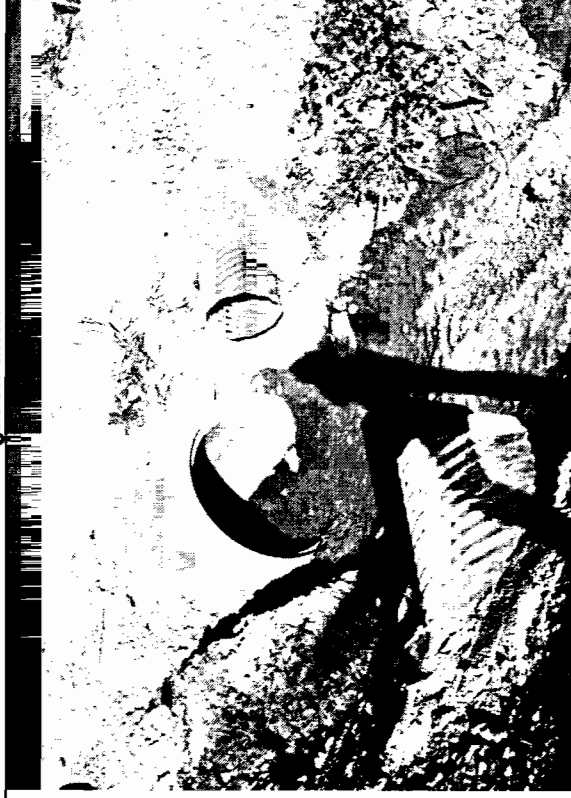
Photograph 8 – Culvert pipe outlet from Photograph 7 to irrigation channel.

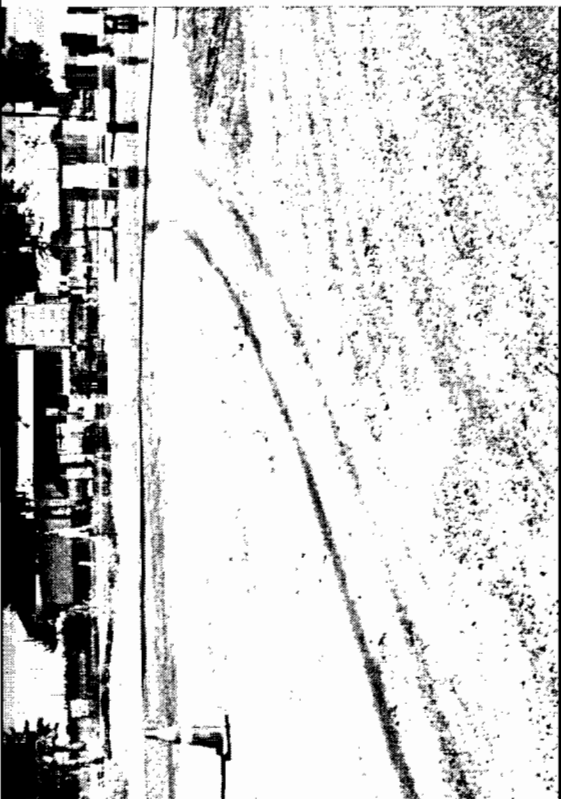
<p>Photograph 11 –Tracking control BMPs were not implemented near Station 346 + 70.</p>	<p>Photograph 12 – No tracking control BMPs implemented at Sta. 346 + 70.</p>

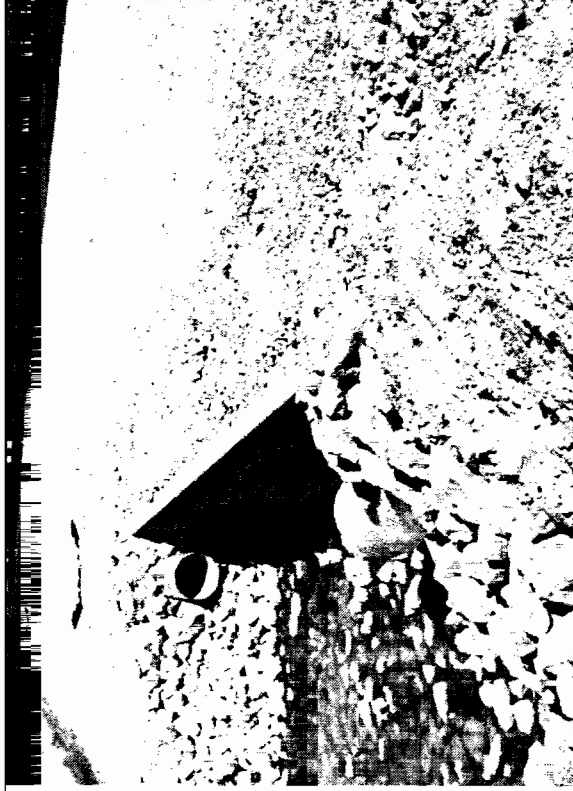
Adequate structural and non-structural BMPs had not been implemented for up-gradient areas of disturbance located directly adjacent to an irrigation channel located at Station 300 + 00 (see Photographs 13 through 16). Specifically, erosion and sediment controls had not been implemented for disturbed slope areas and no inlet protection BMPs had been implemented. As a result, there was a potential for the discharge of sediment from the up-gradient areas of disturbance to the irrigation channel which subsequently drains to levees at Sutter Bypass and ultimately to the Sacramento River.

Photograph 13 – Adequate E&S controls were not implemented for areas of disturbance up-gradient of Irrigation channel (East side)

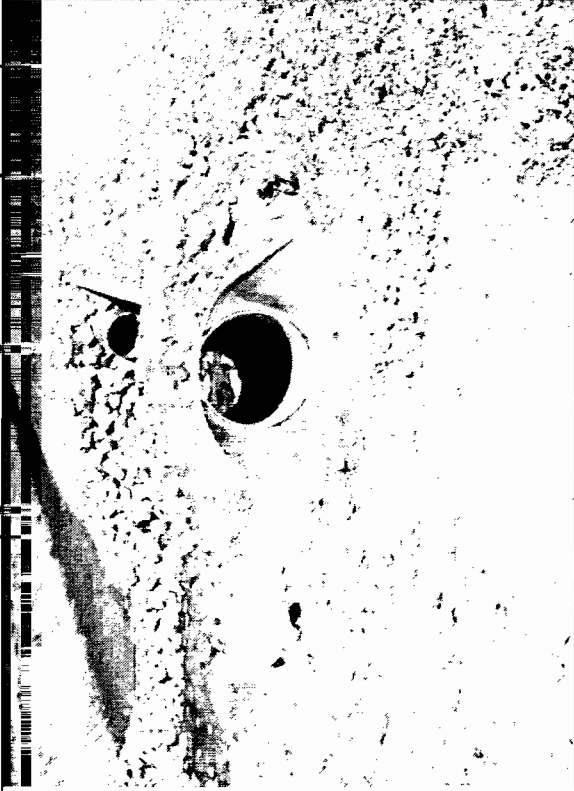
Photograph 15 – Inlet protection BMPs were not implemented for a culvert inlet draining to the Irrigation channel.

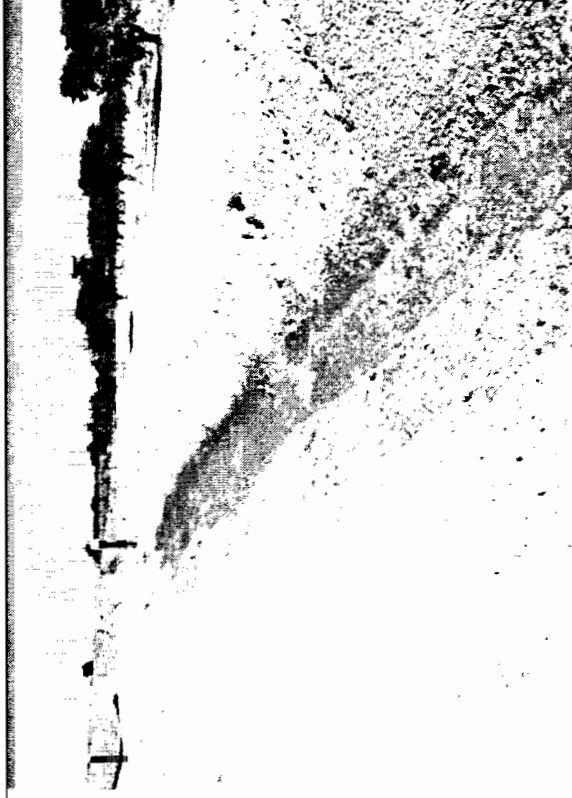
In addition, BMPs were not adequately maintained for the adjacent roadway drainage swale located at approximately Station 300 + 00 on the west side of the roadway. Evidence of erosion (e.g., rill and gully formations) was observed on the drainage swale embankment slopes (see Photographs 17 and 18). As a result, there was a potential for the discharge of sediment to the drainage swale which subsequently drains to the irrigation channel and levees at Sutter Bypass, and ultimately to the Sacramento River.

Photograph 18 – Vantage point view of Photograph 17. Adjacent roadway swale drains to irrigation channel near top of Photograph.

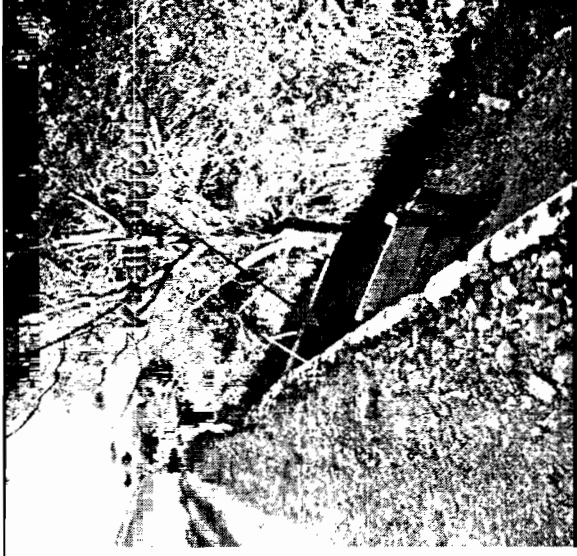
Photograph 4 – Failed area along access road

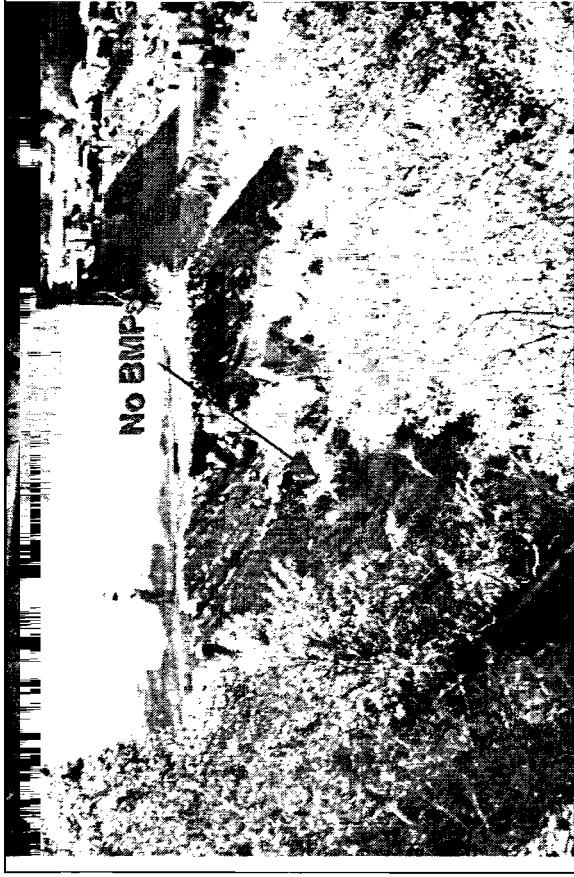
Photograph 5— Fill slope along access road without BMPs

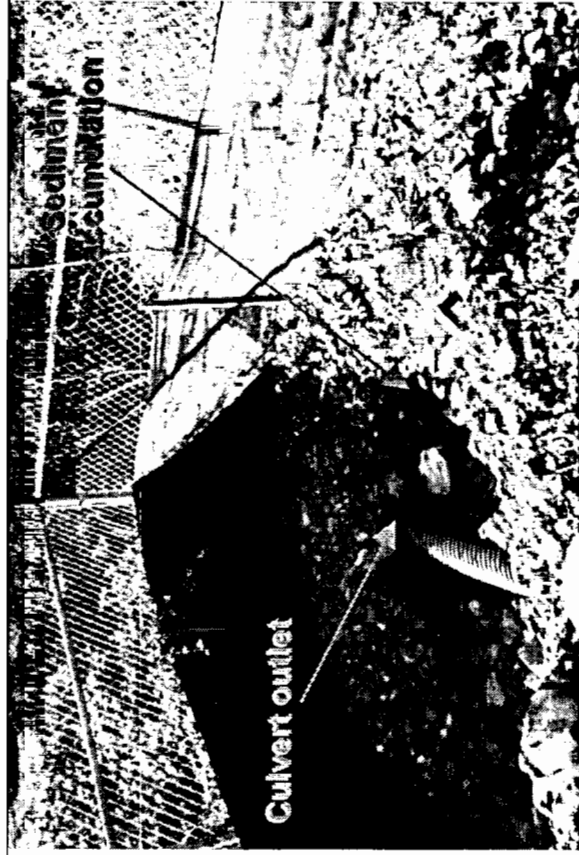
Photograph 3 – Culvert outlet to northwest corner of facility (Note: Silt fence BMP installed backwards)

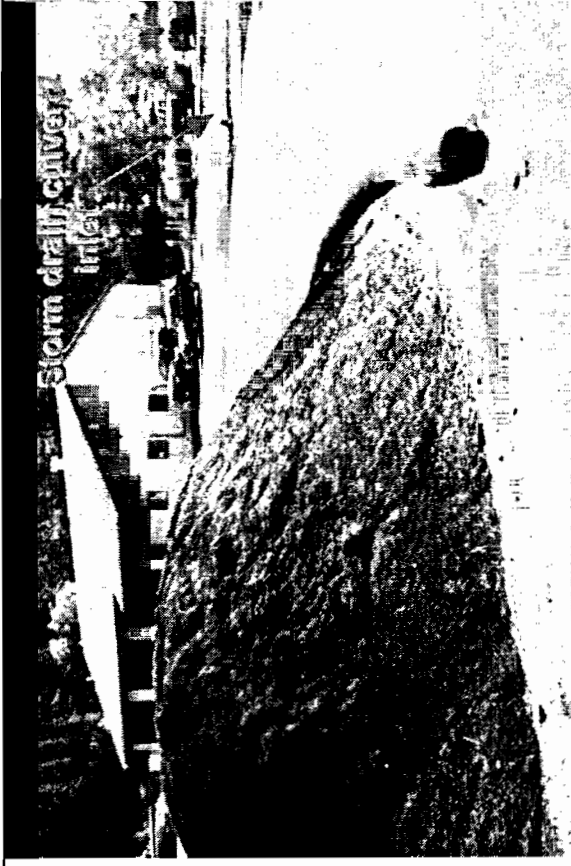
Photograph 6 – Inappropriate application of straw wattle BMP

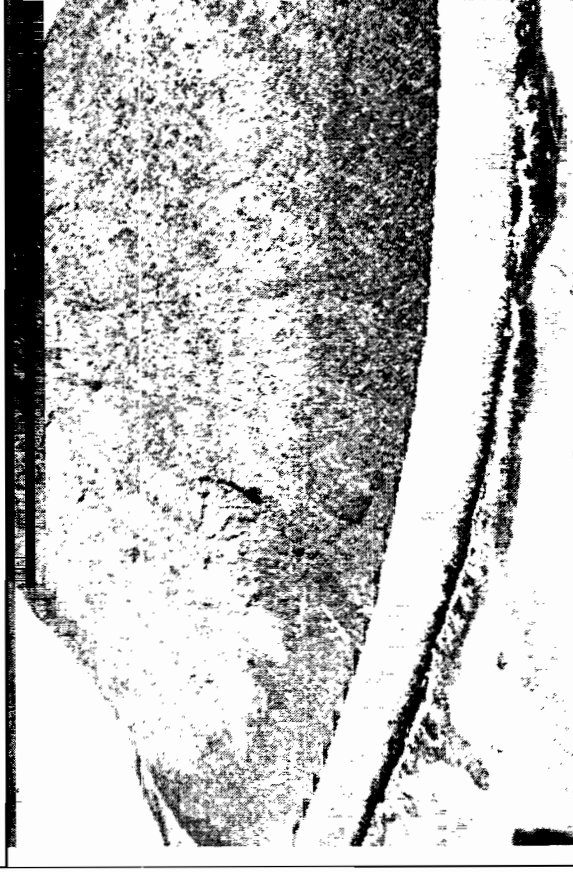
Photograph 7— Closer view of straw wattle BMP around stockpile
(Note: Apparent salt residue)

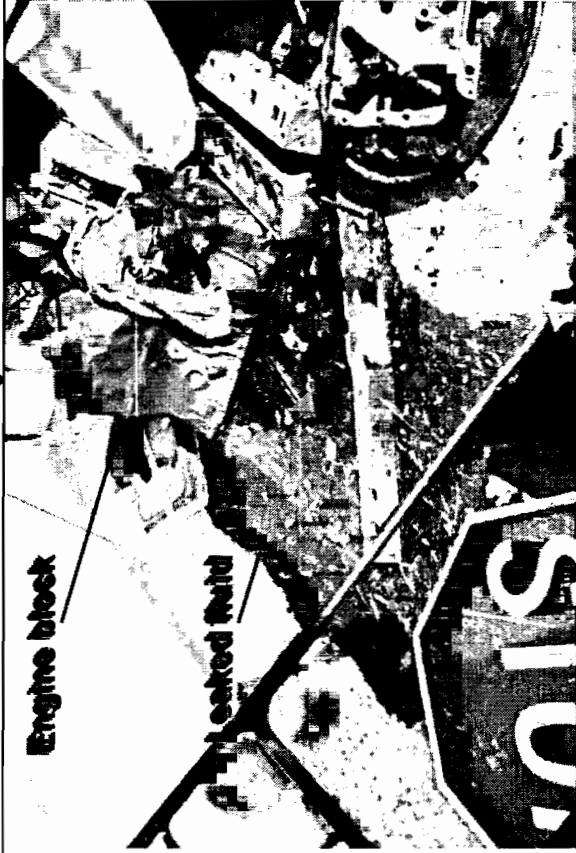
Photograph 11— Engine block stored in metal material storage area
(Note: Fluid on impervious ground surface)

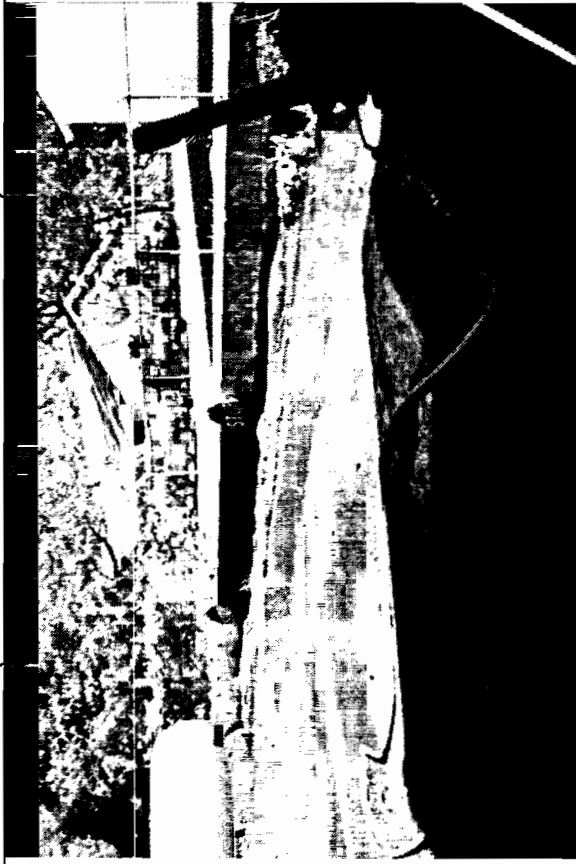
Although the facility is equipped with a designated and covered vehicle and equipment wash rack, a bermed area toward the southern end of the facility is used for truck bed washing (see Photograph 12). An area of wet soil was observed on the backside of the bermed area adjacent to a drainage ditch that flows off-site to the south (see Photographs 13 and 14). As a result, there was a potential for the discharge of pollutants to the drainage ditch, a component of the Caltrans MS4, and subsequently off-site. Appendix D of the Caltrans SWMP, Section 2.15.1, Vehicle and Equipment Cleaning, states "when possible, truck beds should be cleaned using dry cleanup technique (sweep up or shovel out)."

Photograph 12 – Bermed area used for truck bed washing

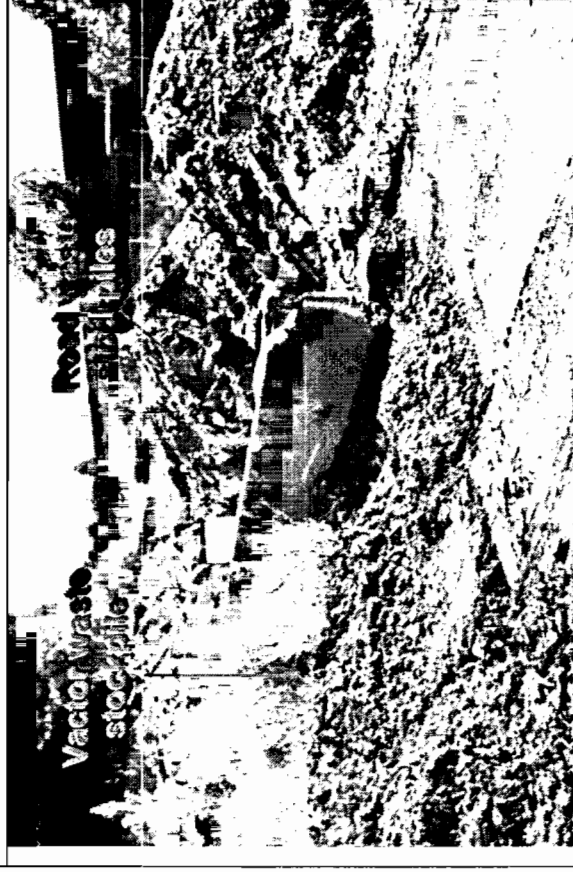
Photograph 3 – Lack of BMPs for containment or coverage of road waste stockpiles

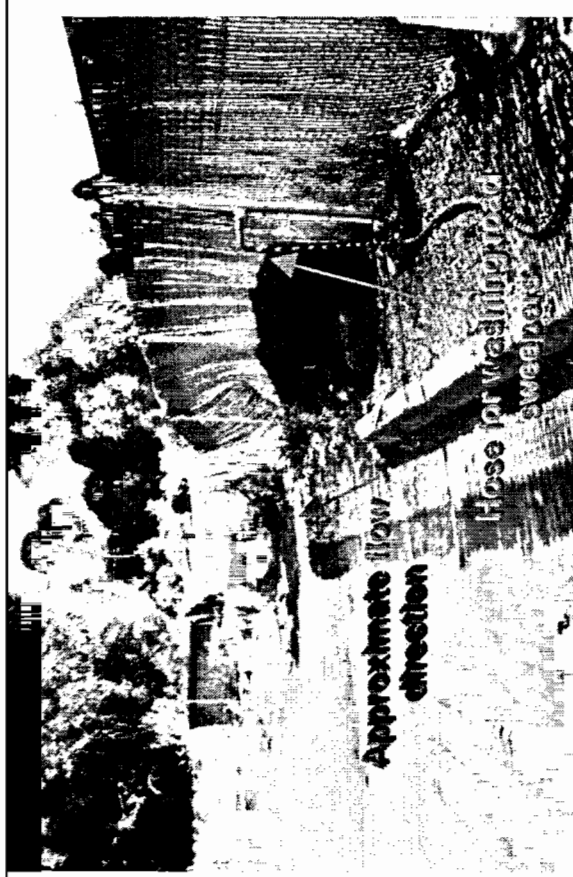
Despite the availability of a designated wash area at the nearby San Leandro Maintenance Yard, a road sweeper pre-washing area was observed along the fenceline of the facility. The pre-washing area is not equipped to properly capture, treat, re-use, or dispose of vehicle wash water and associated pollutants ([see Photographs 6 and 7](#)). As explained by a Caltrans roadway maintenance supervisor from the San Leandro Maintenance Yard, road sweepers are hosed off at the Washington Temporary Storage Site at the end of a working day before they return to the San Leandro Maintenance Yard to be cleaned in the facility’s dedicated wash area. The maintenance supervisor added that this practice is performed to remove large waste from the sweeper before it is in the wash area, so the trough drain at the maintenance yard does not fill up as quickly. It was

Photograph 6 – Location of road sweeper pre-washing area

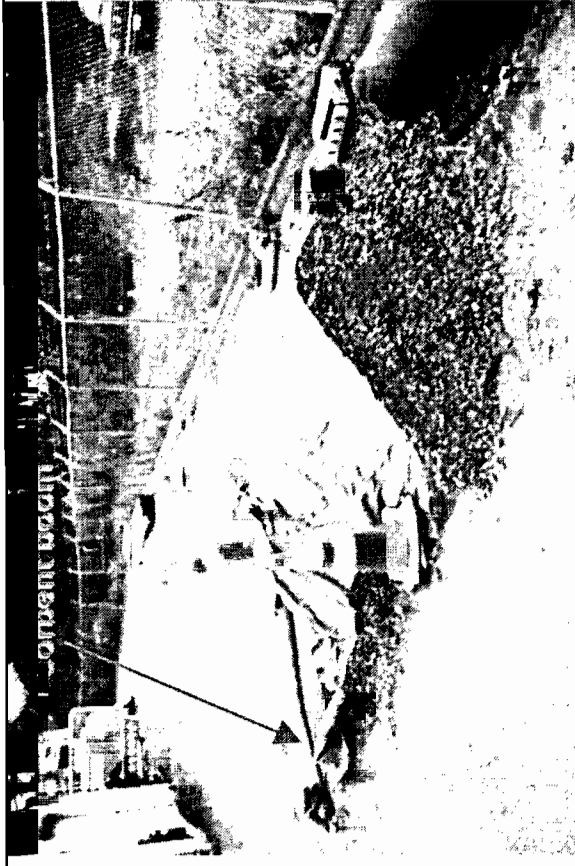
Photograph 10 - Partially covered and contained stockpile along eastern edge of facility

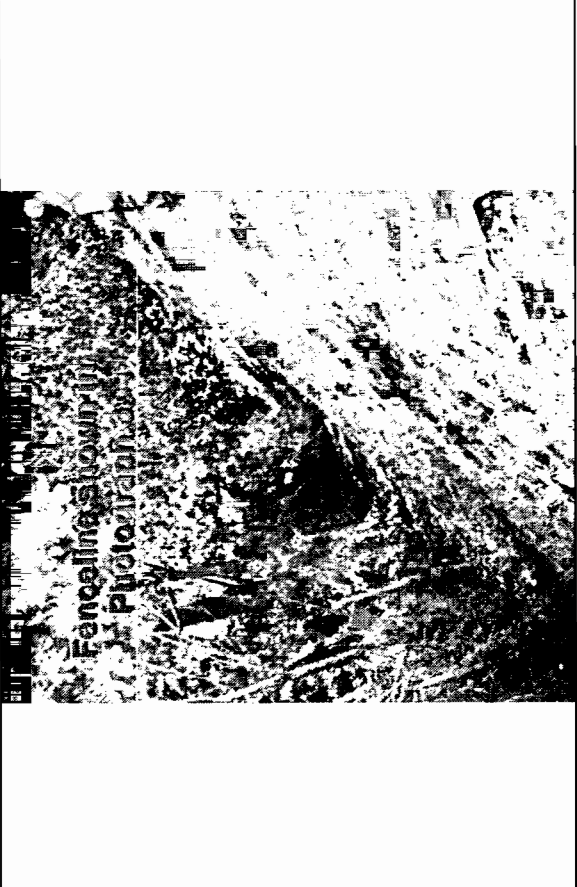
Photograph 4 – View of drainage ditch leading toward South Fork Eel River
